## To Our Valued Customers,

This note affects a specific revision of the iMX6 SoloX COM board (product number: EAC00244). The board is also sold as part of the iMX6 SoloX Developer's Kit (product number: EAK00245).

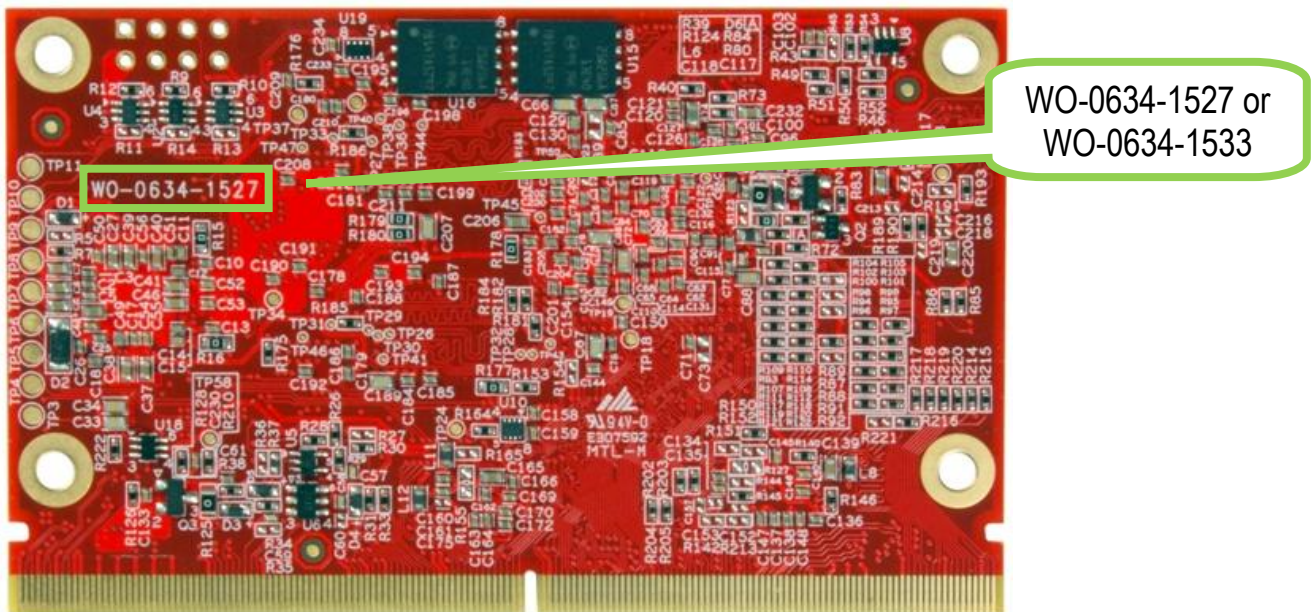
The affected revision of the iMX6 SoloX COM board is identified on the backside of the board, see picture below.

Boards marked with "WO-0634-1527" and "WO-0634-1533" are affected. These are boards called "iMX6SoloX COM board rev A". This text is also printed on the top side of the board. Boards that do not have this exact marking are not affected.

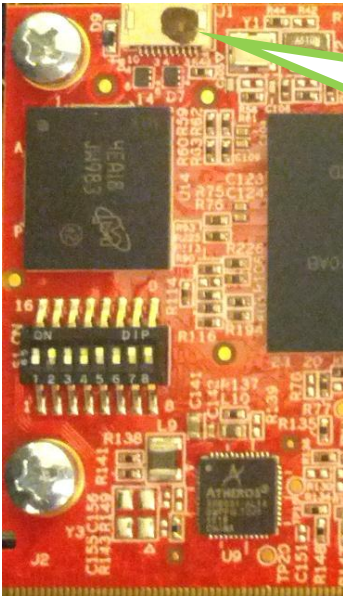
A black dot on the debug connector indicates that the board has already been reworked and is NOT affected by this note.

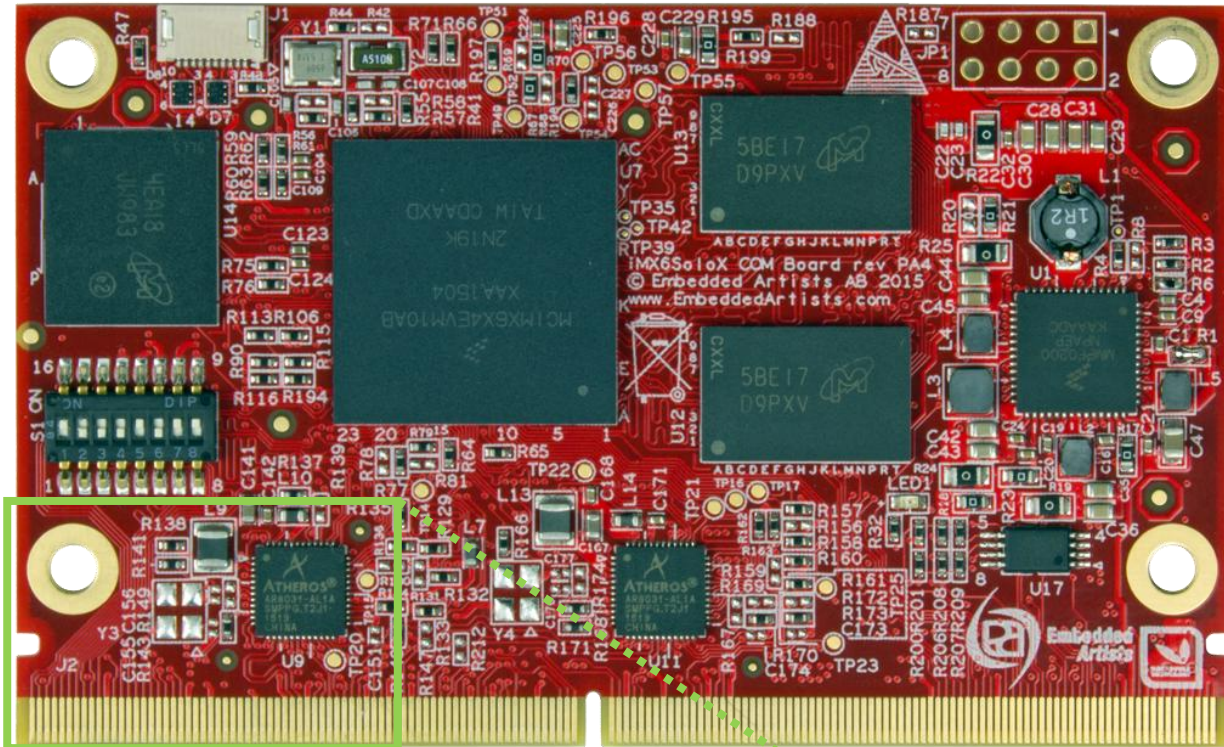
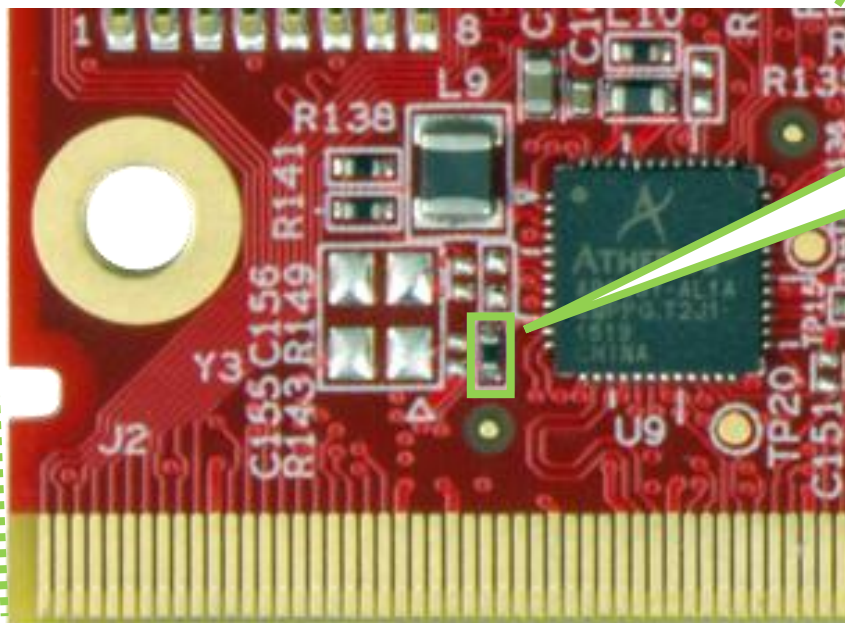
When the parallel RGB interface is active, under some circumstances a reference clock signal to Ethernet interface #0 is affected. This make it impossible to have reliable Ethernet communication on interface #0 (at the same time as the parallel RGB interface is active). The underlying reason is improper impedance matching of the Ethernet reference clock, causing ISI noise.

Replace R143 with a 20, 22 or 30 ohm resistor (0402-size). See pictures below to locate R143.

Replace R143 with  
20, 22 or 30 ohm  
resistor (0402-size).
