Product Note LPCXpresso1769/CD rev D

This product note describes a behavior of the **LPCXpresso1769/CD board, rev D**, that can cause problems. Typical symptoms are:

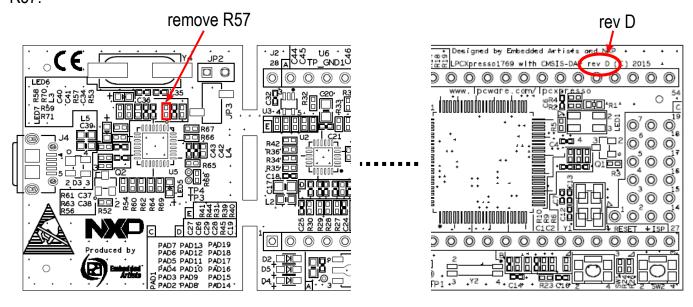
- Debugging works when the LPCXpresso1769/CD board is standalone, but stops working when mounted on a base board.
- A "CRP DISABLD" USB drive appears on the PC instead of the debug interface.

The debug MCU (LPC11U35) will start-up in ISP mode if an external reset signal is low during power-up. This is a typical situation if there is a reset generator on the base board.

Only rev D boards are affected. See picture below for locating revision text and also to locate R57.

Remove R57 on the LPCXpresso1769/CD board. This will disconnect the ISP enable signal on the LPC11U35 from the external reset signal.

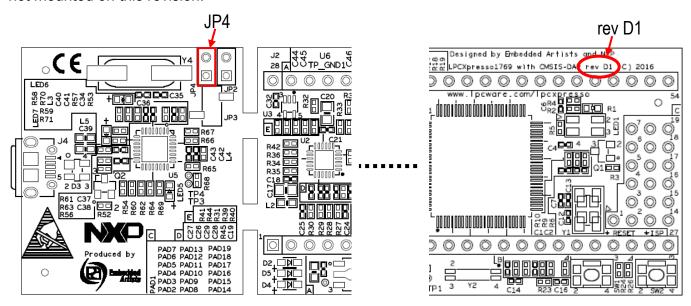
Note that rev D1 boards are not affected. See picture below for location revision text. R57 is not mounted on this revision.
