This PCN affects our iMX8M Mini uCOM board (product number: EAC00336 and EAC00349).

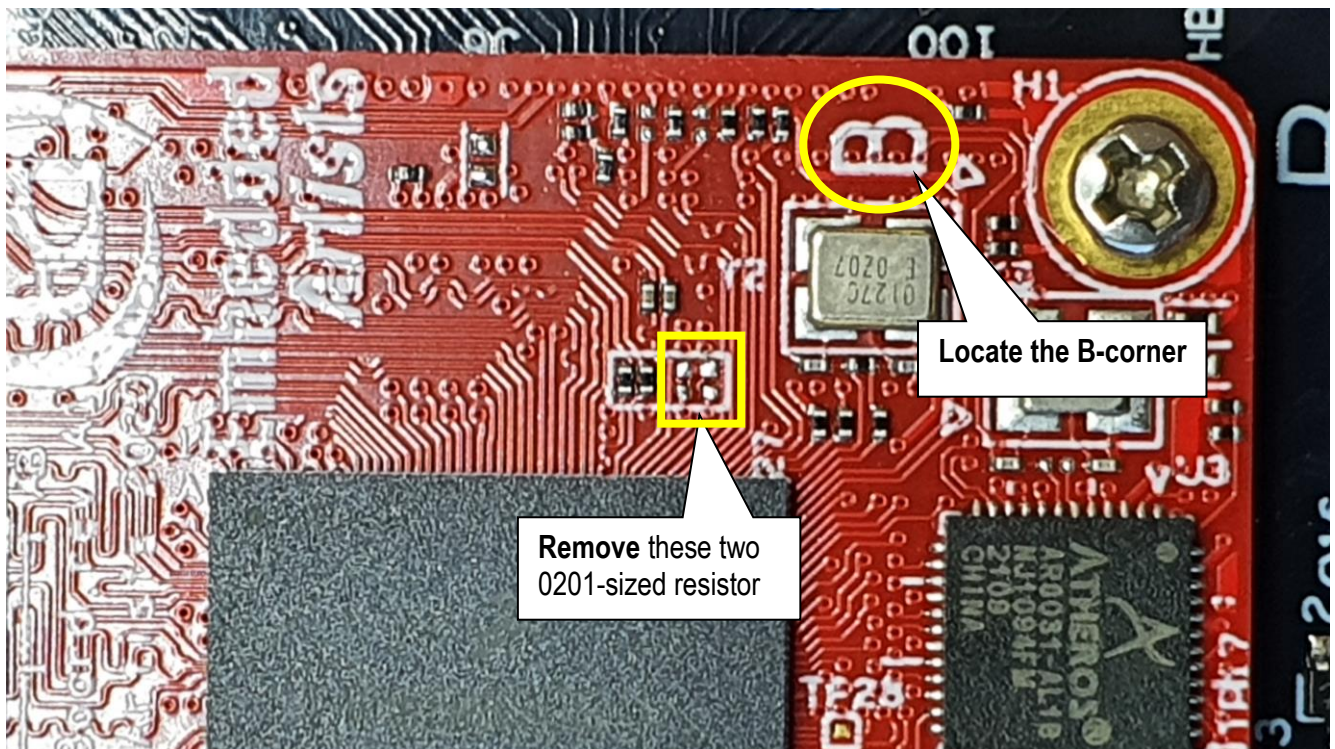
The 100MHz PCIe clock inputs have had incorrect termination on some early board revisions. There are 50 ohm termination resistors to ground close to the clock inputs to the iMX8M Mini processor. The clock inputs on the processor already have internal 50 ohm termination resistors so the external termination resistors will in effect half the clock signal amplitude and hence lower noise margins on the PCIe interface.

No customers have reported any issue, since the margins are very good to start with, but we recommend removing the termination resistors to improve margins.

The rework is simple and done on the top side of the board, see picture below. First identify the B-corner on the iMX8M Mini uCOM board. Then identify the termination resistors that shall be removed.

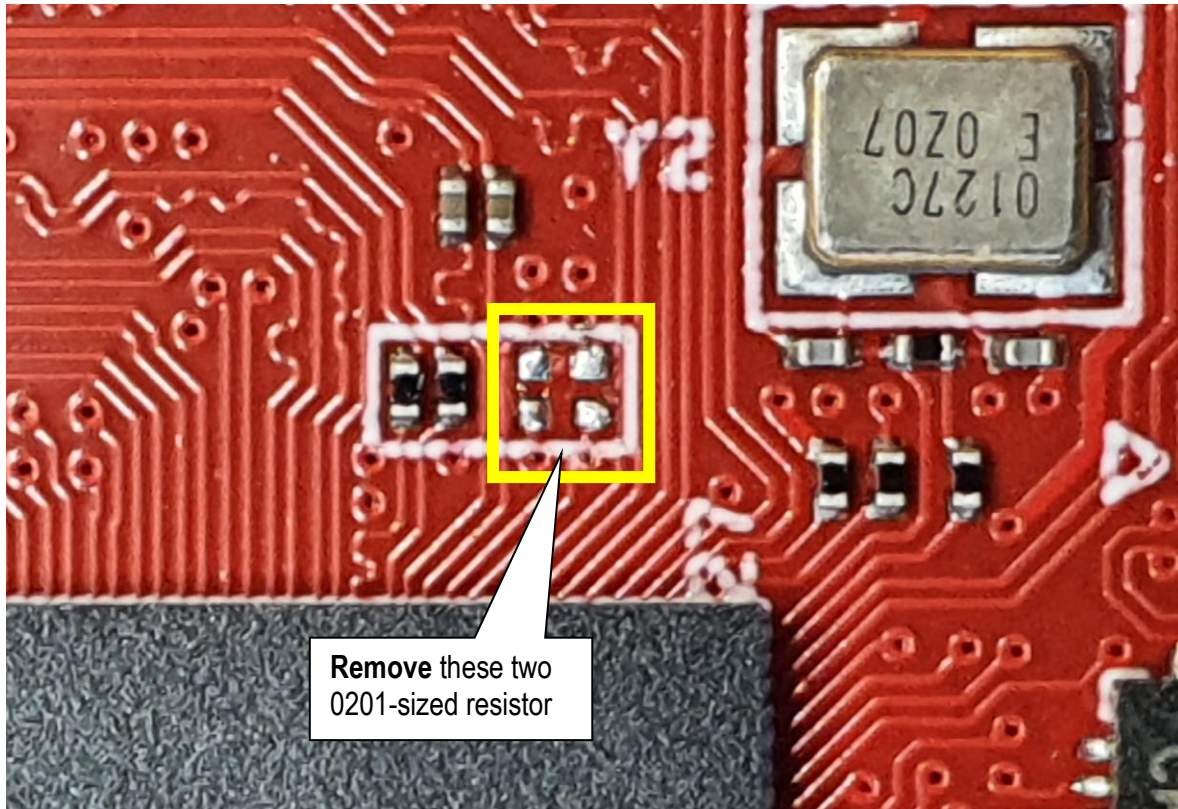
The picture below illustrates a more detailed view of the resistors to remove.
