This note is related to our iMX RT1176 uCOM boards (product numbers: EAC00377 and EAC00381), revisions PA4, A and PB1. Only a few boards have been released of these initial board versions. At the time of writing, the current board revision is C1 and the issue no longer exists.

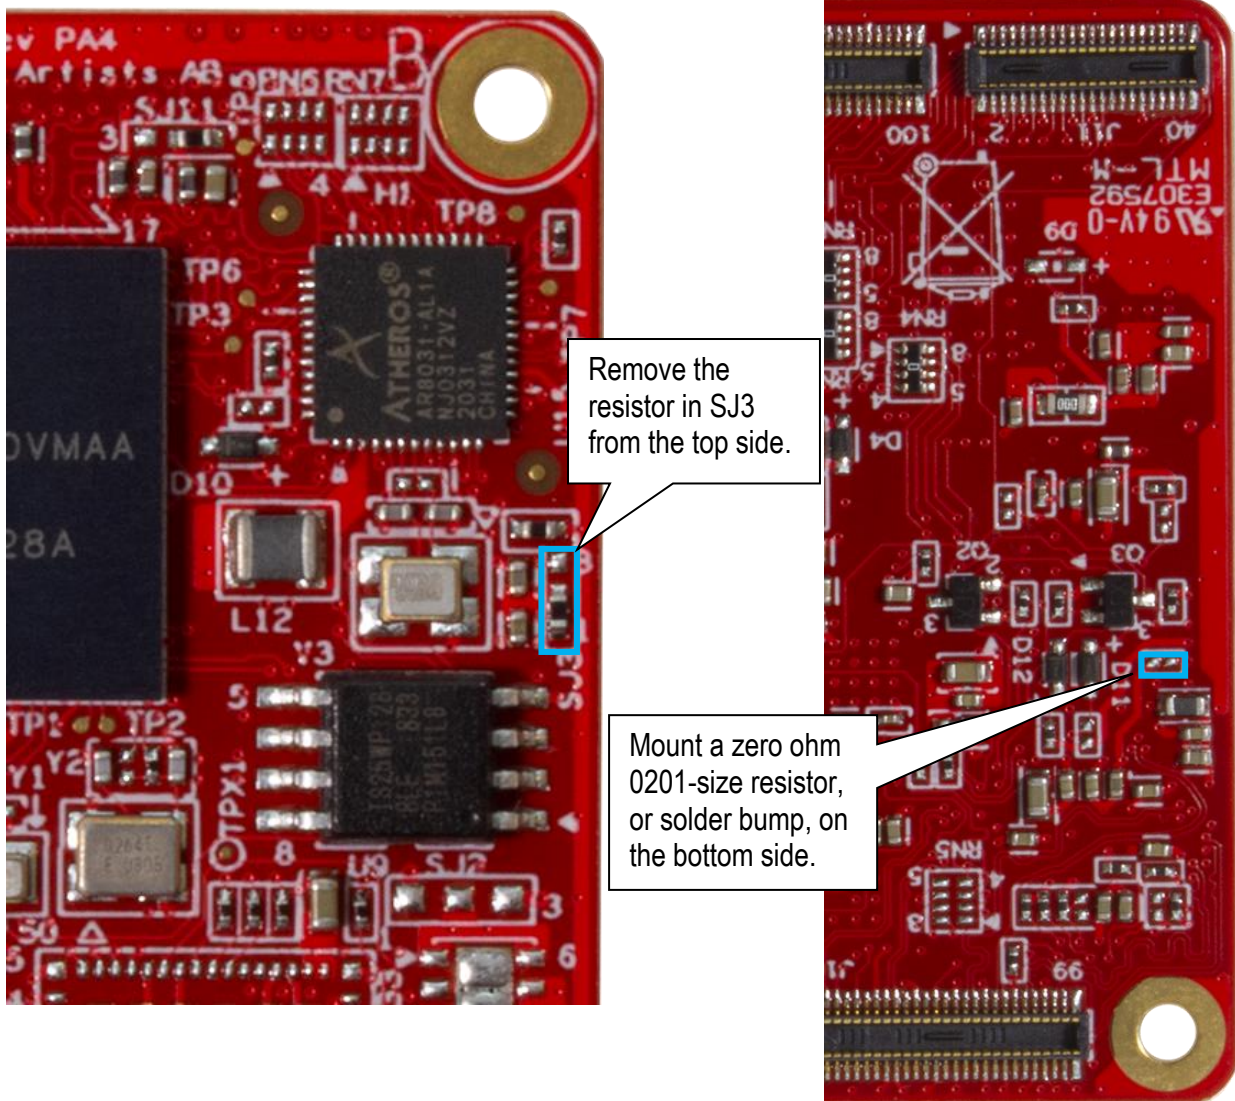
The voltage signaling level on the MDC/MDIO signals is 1.8V and this is out-of-spec. We have not experienced any problems during production test but under some circumstances it can be impossible to communicate with the Ethernet-Phy over the MDC/MDIO interface.

The solution is simple and only requires a small rework, see below. Remove one resistor on the top side and mount one on the bottom side. The signaling voltage is changed to 2.5V.

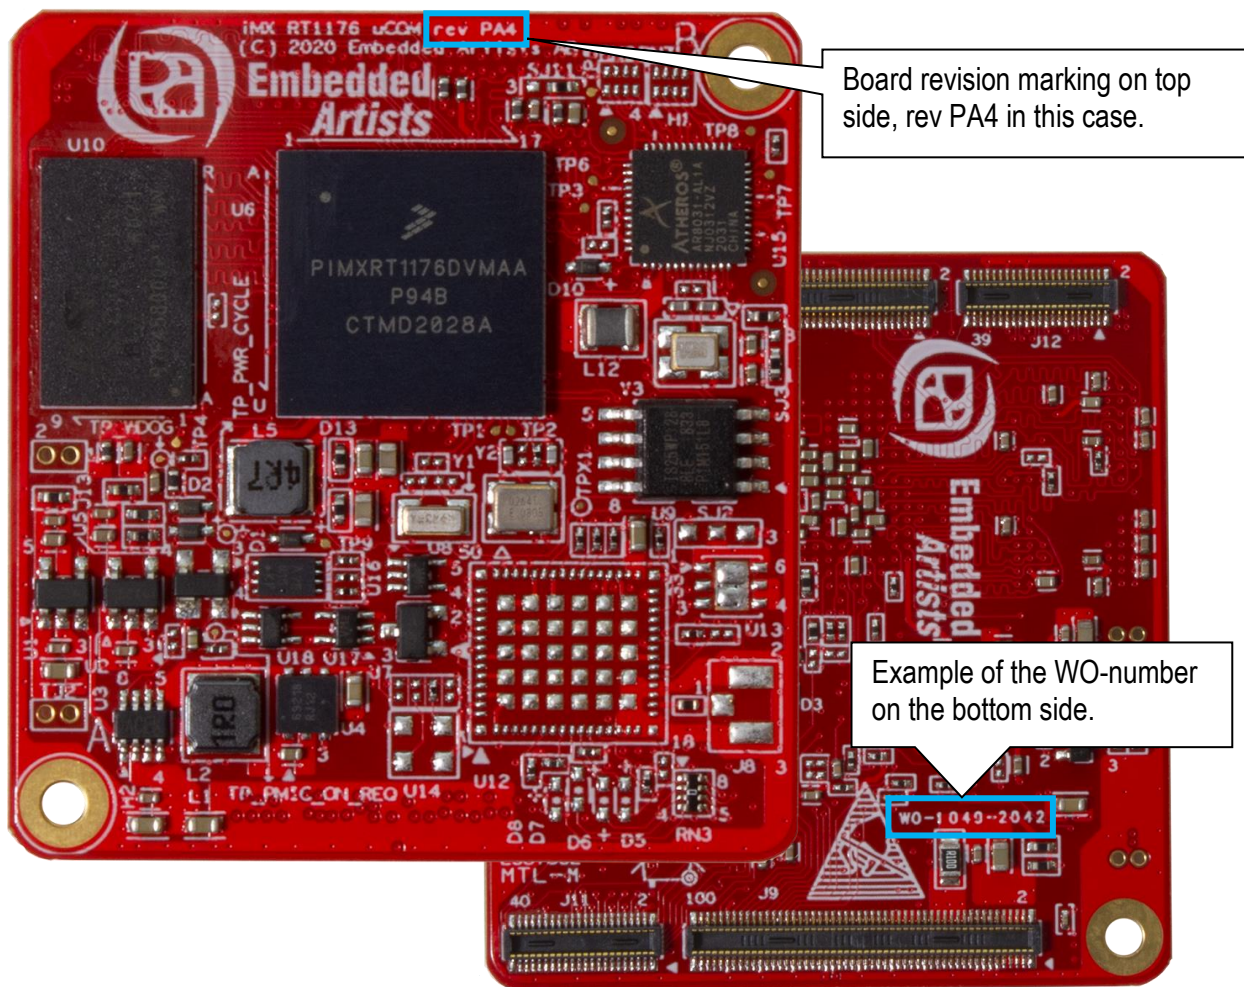
Identification

The issue affects boards of revision PA4, A and PB1. These are all produced (in a small total number) before November 2021. All boards from Embedded Artists have a marking: WO-XXXX-YYWW, where XXXX is the WO-number. YY is the year and WW is the week number when the board was produced.

The affected boards will have a WO-number below or including: XXXX < 1099, and have board revisions “PA4”, “A” or “PB1”. See picture below how to identify the board.
